LANDSLIDE SOILS AND GEOMORPHOLOGY IN CAMP DAVIS
QUADRANGLE, BRIDGER-TETON NATIONAL FOREST, WYOMING

Submitted to the graduate degree program in Geography
and Graduate Faculty of the University of Kansas
in partial fulfillment of the requirements for the degree
Master's of Arts

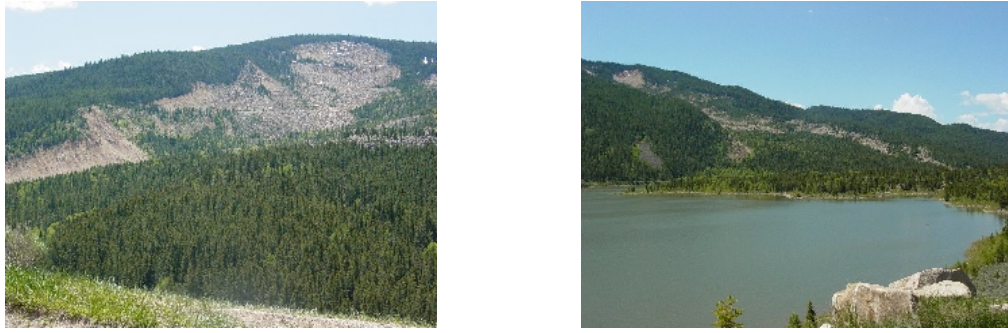
Figure 13 - Scarp of Gros Ventre slide (left); Lower Slide Lake (right), formed by damming of slide debris (Dutch 2003)

On June 23, 1925, a one-mile-wide section of earth northeast of Jackson collapsed, damming the Gros Ventre River and creating Lower Slide Lake (Figure 14, USDA 2007). Two years later the dam failed and destroyed the town of Kelly, WY. This event, known as the Gros Ventre slide, is the largest natural landslide in the recorded history of the United States (American Geological Institute 2007). While this landslide is known worldwide for its size and dramatic impact on the surrounding community, it is by no means the only mass movement that has occurred in BTNF. In fact, in few parts of the U.S. is landsliding so prominent a geomorphic process as in Bridger-Teton National Forest (Bailey 1971).

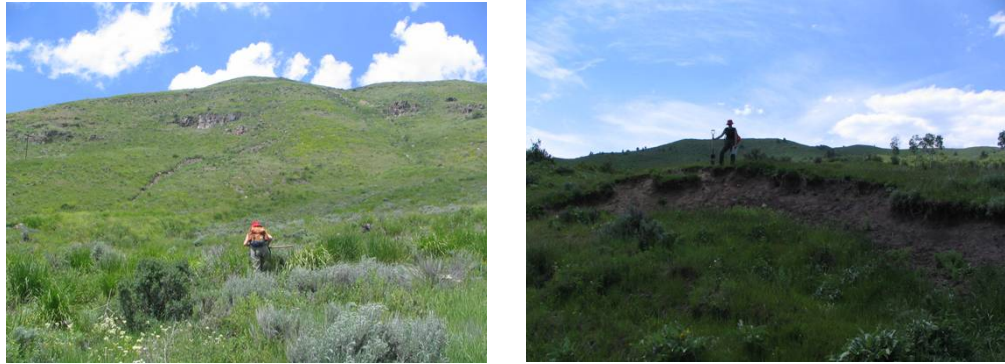
Figure 17 - Visible scarps indicate locations of past landslides. Camp Davis Quadrangle, Wyoming.

The prevalence of landslides in Camp Davis Quadrangle leaves an unmistakable impression on the landscape. Hummocky topography, visible as lumpy, bumpy hillslopes, is evident throughout the quadrangle. This type of topography is created as repeated failures impact a hillslope, leaving concave depressions above and mounds of deposited debris below repeatedly on slopes. The soil survey for this region describes surfaces with benches and bench-like features, as well, and points to these as evidence of prior mass failure (Nordin & Blackwell 1985). Bare scarps and displaced or broken bedrock, other consequences of frequent landsliding, are observed throughout the quadrangle (Figure 17).

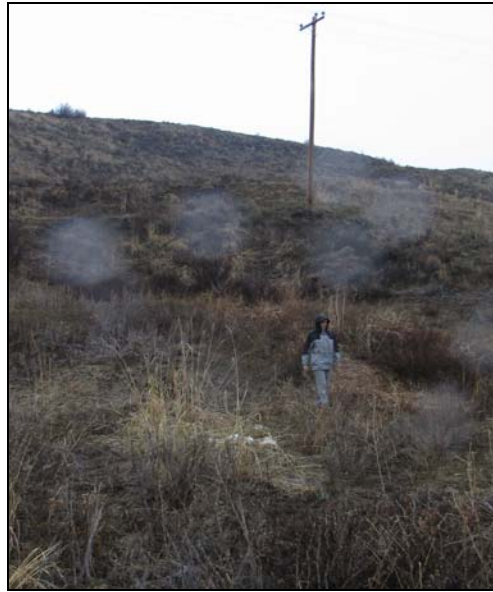
Figure 18 - Hummocky topography, seep pools, knolls and depressions at Hoback Junction, Camp Davis Quadrangle, Wyoming.

Vegetation and drainage patterns in the quadrangle are often dictated by mass wasting processes, as well. Surfaces impacted by landslides often display unconsolidated drainages with slump ponds and seeps covering the surface. At locations in the quadrangle where repeated failures have occurred at various scales, such as the Hoback Junction area, unconsolidated drainage, hummocky topography, and slump/seep pools – “a jumble of knolls and undrained depressions” are observed (Bailey 1971, Figure 18).

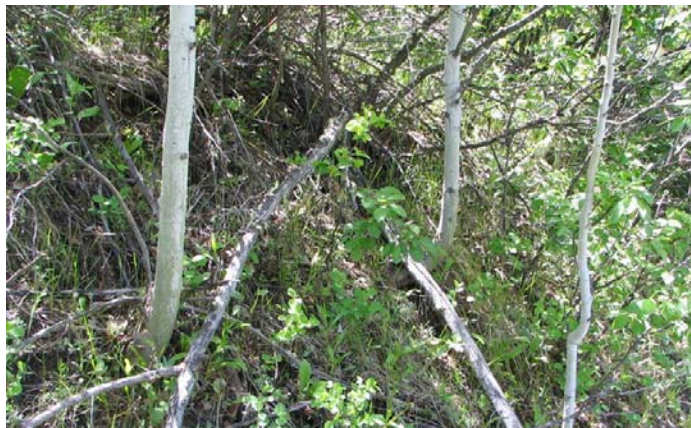
Figure 19 - Pistol-butted trees observed on Ross Plateau, Camp Davis Quadrangle, Wyoming

sometimes develop bent trunks as they re-grow their trunks straight after being tilted downslope by instability (Bailey 1971). These two vegetation characteristics are commonly observed in Camp Davis Quadrangle (Figure 19, 20).

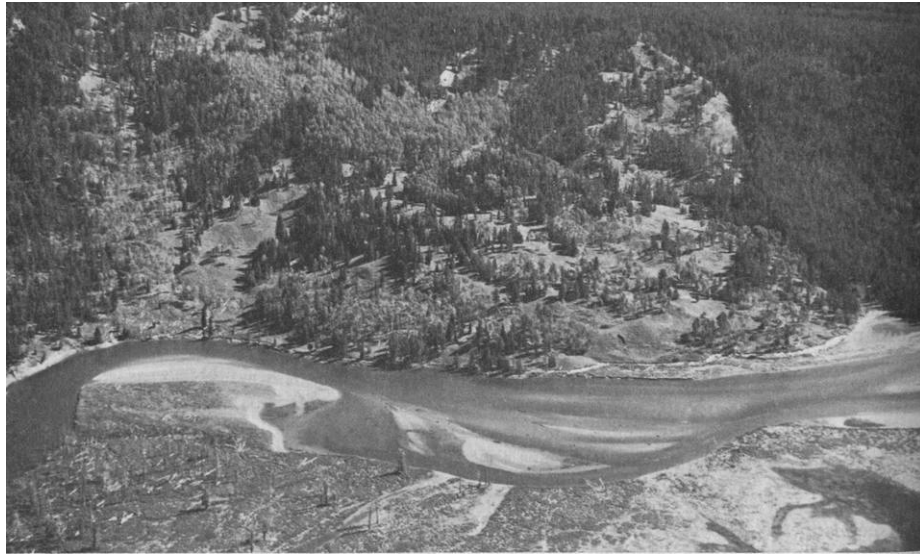
Figure 20 - Contrasting vegetation on slump/debris flow (Aspen, bare ground) and surrounding stable area (mature conifer forest), Snake River, BTNF. Source: Bailey 1971

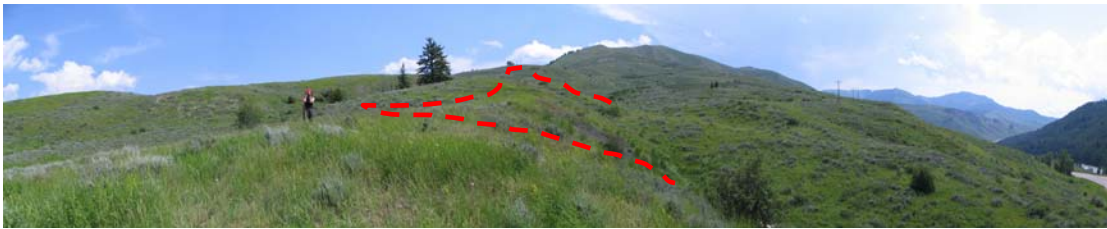
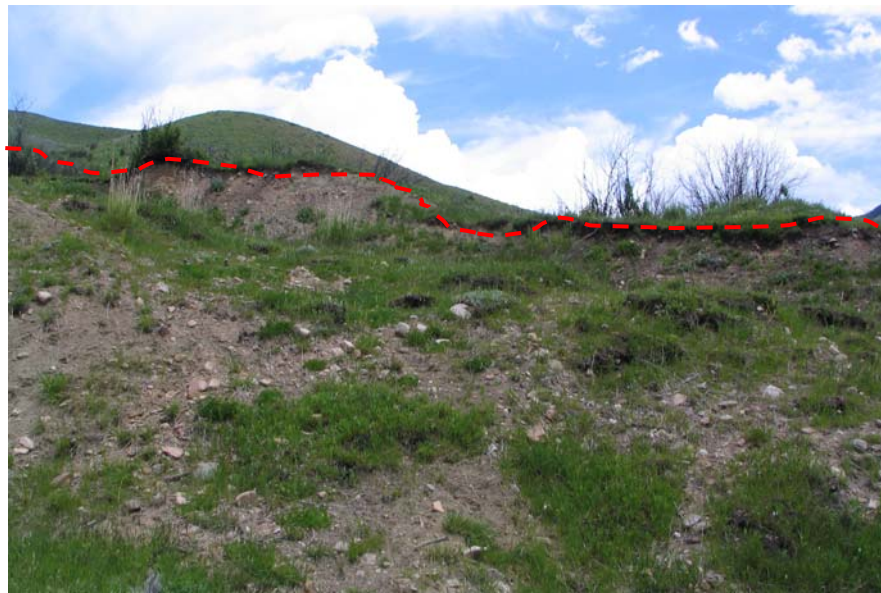
Figure 21 – Smooth, vegetated scarp observed at landslide no. 14 (top photo), and sharp, partially vegetated scarp observed at landslide no. 2 (bottom photo). Scarps are traced in red.

(nos. 3, 5, 9, 15, 16). Lateral scarps were not evident on eight landslides (nos. 1, 12, 13, 17, 19, 20, 22, 23), vague on one landslide (no. 7), smooth on three landslides (nos. 14, 18, 21) and sharp on six landslides (nos. 2, 3, 5, 9, 15, 16). Lateral scarps on eight landslides were vegetated (nos. 12, 13, 17, 18, 19, 20, 22, 23), on four landslides were partially vegetated (nos. 1, 7, 14, 21) and unvegetated on six landslides (nos. 2, 3, 5, 9, 15, 16).

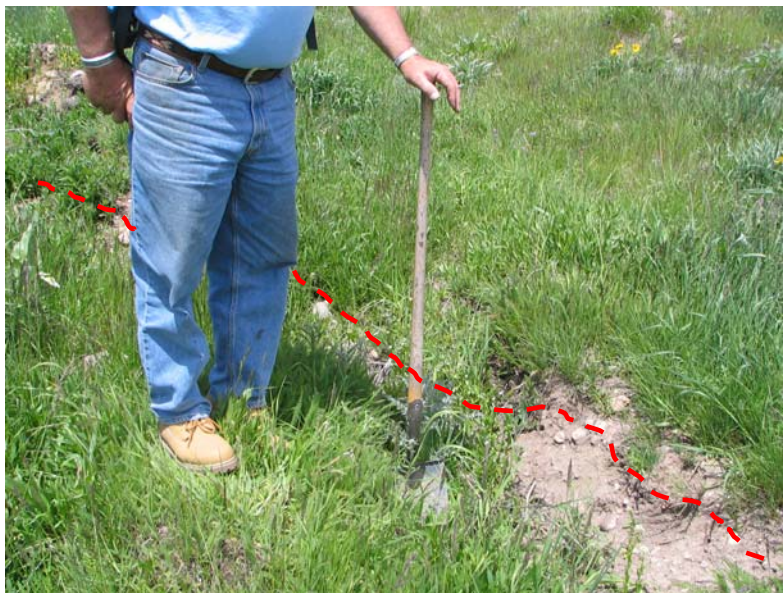
Figure 22 – An unvegetated crack, (traced in red), observed on landslide no. 2.

Unvegetated cracks on the soil surface of the landslide body were observed on 11 landslides (nos. 2, 3, 5, 7, 9, 12, 14, 15, 16, 21, 23, Figure 22) and were not seen on the seven other slides. Hummocky topography was observed on all but four slides, where the landslide topography was described as smooth and rolling (nos. 1, 16, 17, 18). Slide planes and/or detachments were detectable at nine slides (nos. 2, 3, 5, 7, 9, 12, 15, 16, 21, Figure 23), but not at the nine other slides. An extensive marshy area was present at the toe of landslide no. 3, along Little Horse Creek, and a large, intact pond was present at the toe of landslide no. 13 (Figure 24). Drained and/or undrained depressions were observed at nine of the eighteen landslides studied (nos. 2, 3, 5, 7, 9, 12, 13, 15, 22).

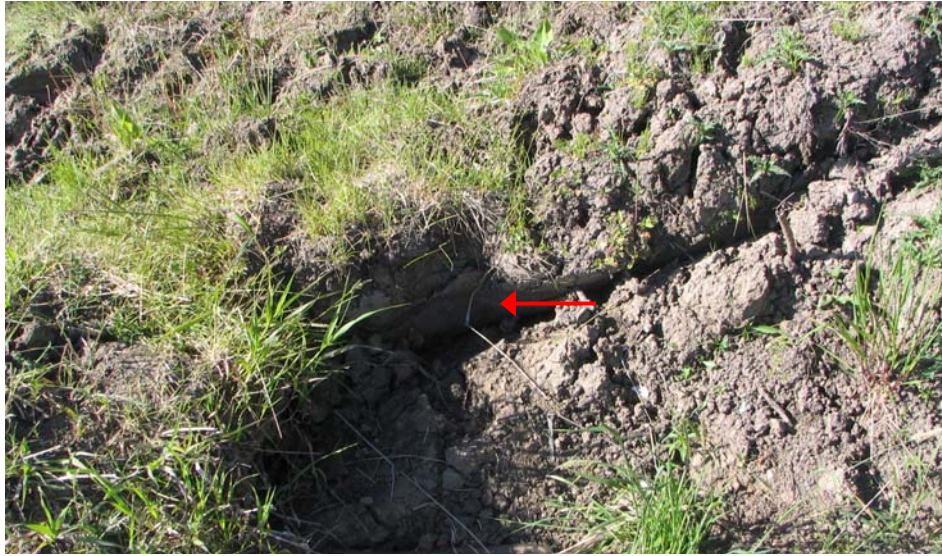
Figure 23 – A plane of displacement (slide plane) observed on landslide no. 9. The shiny appearance of the slide surface is noticable in the center of the photo (red arrow).

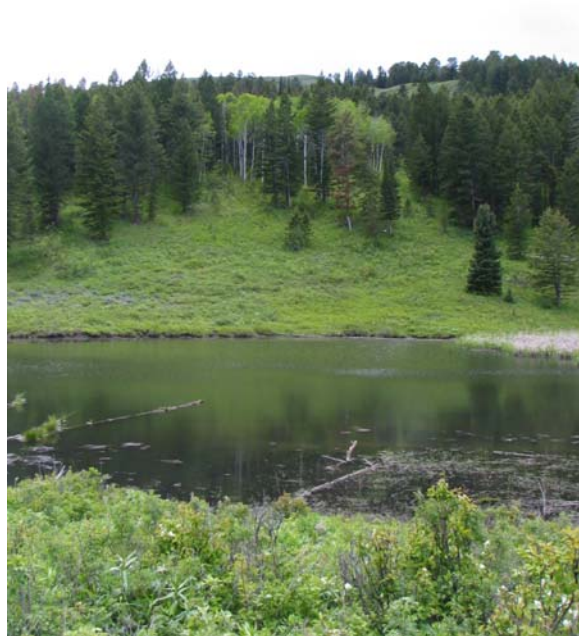
Figure 24 – A stable pond, indicated by beaver activity and well-established vegetation, observed at the toe of landslide no. 13.
